18 AFRPL TR-77-49

19 14 6 IMPROVED JET TAB THRUST VECTOR CONTROL FOR THE BGM-34C BOOSTER.

9 FINAL REPORT, May 75 - Jun 77

TRW SYSTEMS GROUP  
ONE SPACE PARK  
REDONDO BEACH, CALIFORNIA 90278

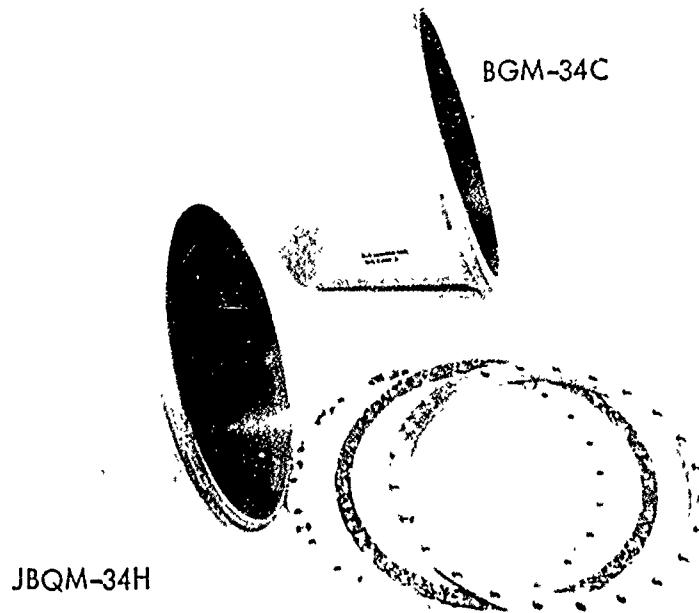
Figure 4-11. Nozzle Liner/Scraper Ring Comparison

Because of the low risk approach used during the JBQM-34H program, an infiltrated tungsten scraper ring was used at the nozzle exit plane to eliminate the effects of gas wash when a tab was inserted. During that program, molybdenum had been used with no apparent difficulty. The lowest cost approach, however, would be to eliminate the refractory metal with its attendant insulator and steel retaining ring. By extending the nozzle liner to include the scraper ring function, several parts could be eliminated as shown in Figure 4-11. The only attendant problem was the extent of performance degradation associated with the eroding nozzle exit.

In addition to a molybdenum scraper ring, three ablative materials were tested. The two nozzle liner materials, MX2600 and pitch carbon fabric phenolic, were tested in addition to carbon cloth phenolic (MX4926). The erosion characteristics and resultant minimal reduction in vector performance allowed the use of a single piece of silica phenolic.

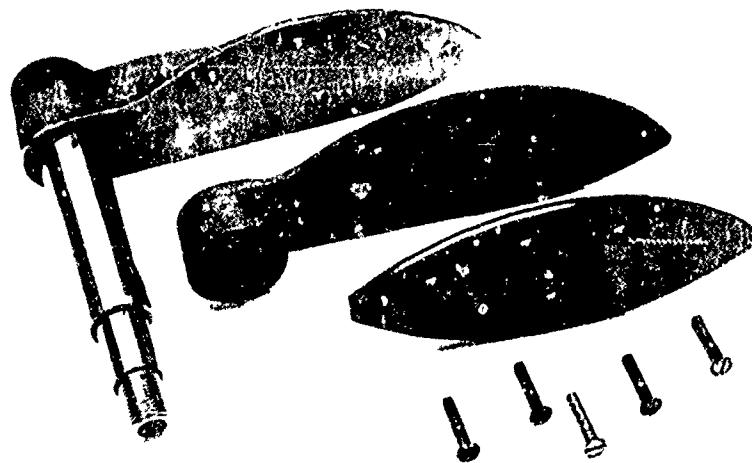
Figure 4-12. Countersunk Tab Screw Installation

The bolts used to fasten the tab face to the structural support were fabricated from a tantalum-tungsten alloy (TA-10W). The material selection was satisfactory, however, a design change was made when test difficulties were encountered. During the JBQM-34H program and the early part of this program, the bolts, Figure 4-12, were installed with a countersunk head from the tab facing through clearance holes in the support. Problems were experienced with the near loss of bolt heads. This problem was eliminated by installing the bolts from the support into tapped holes in the refractory face.

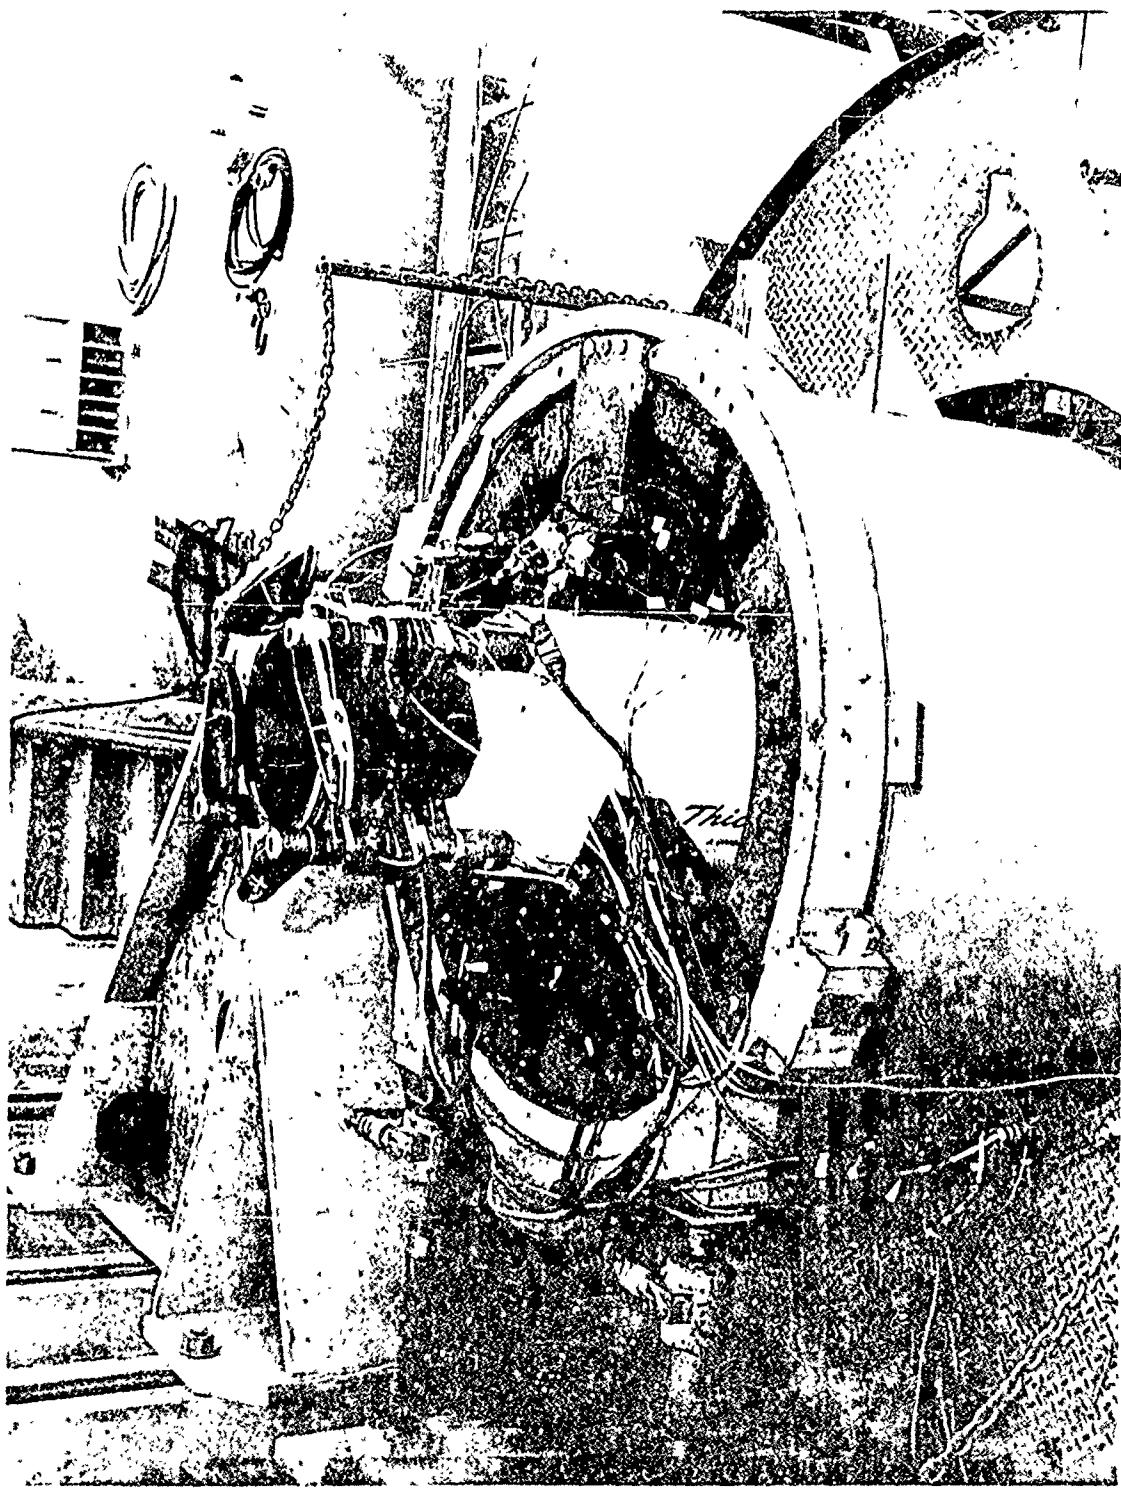
Figure 5-3. Test Unit PI-2 Installed on AFRPL Char Motor Stand

Both product improvement test firings were successfully accomplished. The test firings were conducted at the AFRPL with the jet tab TVC system installed on a TU-752 solid rocket motor. Test unit PI-2, installed on the AFRPL 40 inch Char motor thrust stand, is shown in Figure 5-3.

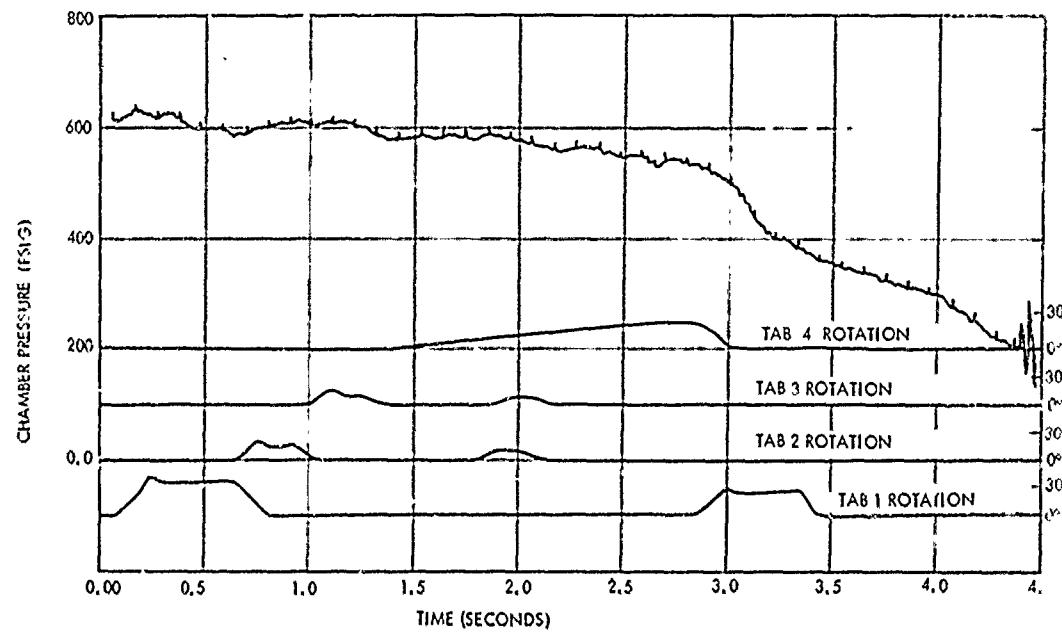
Figure 5-4. Motor Chamber Pressure and Tab Actuation, PI-1

For test firing PI-1, the tab operation sequence indicated in Figure 5-4 provided a maximum of 1.6 seconds exposure on the instrumented tab.

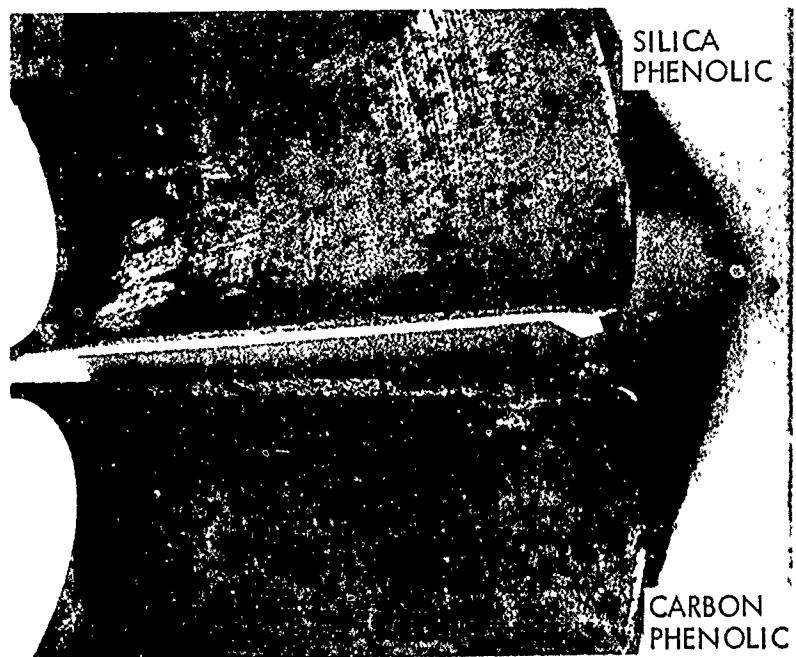
Figure 5-9. Nozzle Liner Erosion Comparison

Both nozzle exit liner materials exhibited equal erosion under the tab for equivalent duty cycles (Figure 5-9). For the scraper ring material, no appreciable erosion was measured. As can be seen in Figure 5-10, the erosion experienced on the carbon phenolic insert was minor (tab insertion angles, however, were low).

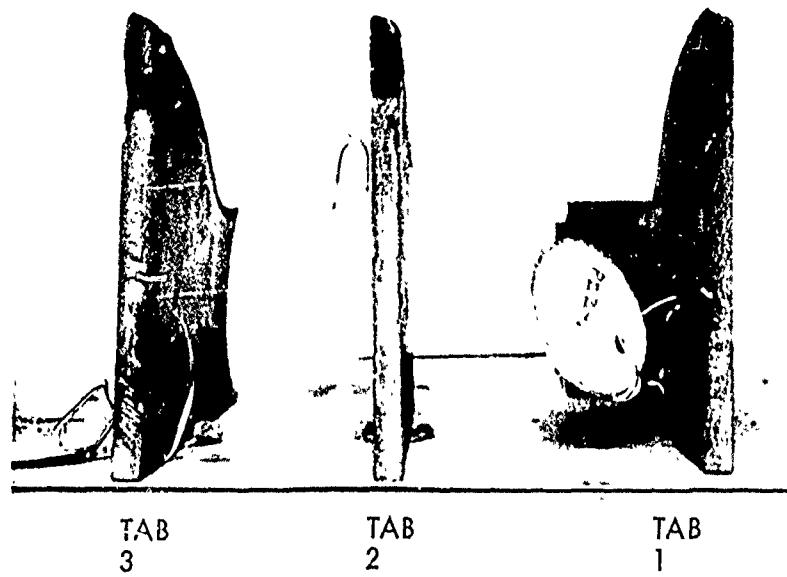
Figure 5-11. Blade Insulator Test PI-2

The three low cost insulating materials all exhibited adequate thermal margins. The relative char depth for equivalent exposure time is shown in Figure 5-11. An equivalent amount of erosion was experienced on both thicknesses of molybdenum tested. A relative comparison of the four tab facings used during test PI-2 is shown in Figure 5-12. A summary of thermal response of the instrumented tab facings is shown in Table 5-4.

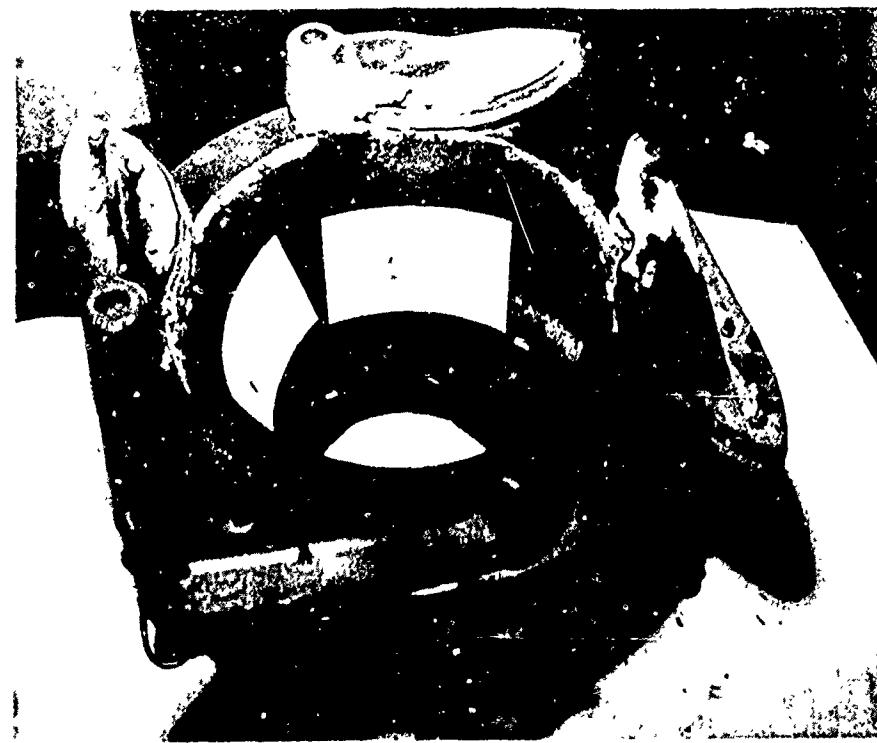
Figure 5-19. PFRT-02 Test Unit Post Test

The post test condition of the hardware on both test units was very satisfactory. Test unit PFRT-02 is shown in Figure 5-19. Erosion of the phenolic liners for both the silica phenolic and pitch carbon fabric phenolic materials was considered acceptable. In general, erosion of the liner immediately under the tab was equivalent in both materials and as can be seen in Figure 5-20, occurred back to the screws retaining the liner to the housing. Erosion of the molybdenum tab facings was well within acceptable limits. Total exposure time for each tab was in excess of three seconds during motor burn time with up to one additional second of exposure during tail off. The .25 inch thick molybdenum showed only minimal material loss (Figure 5-21), while the .375 inch material had a local material loss of nearly half the thickness (Figure 5-22). While

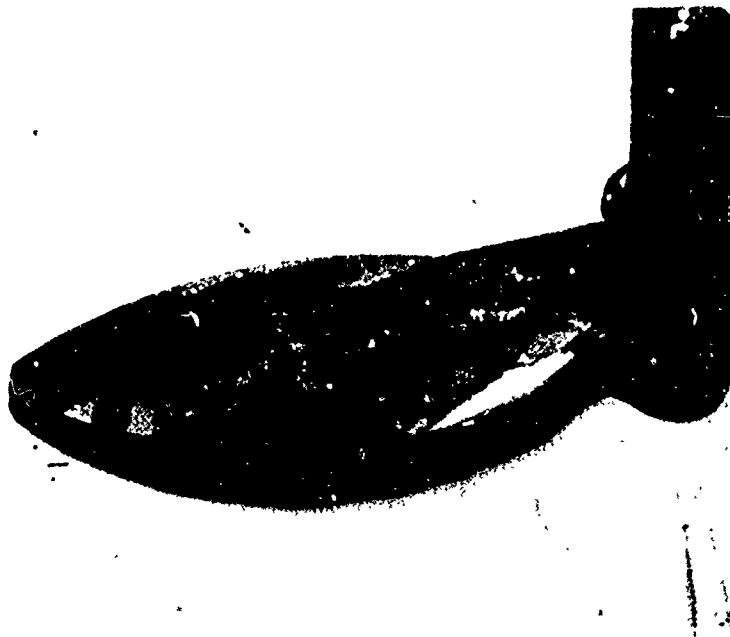
Figure 5-23. Shaft Insulator Erosion

The only material condition which approached marginal service during the test firing was the portion of the tab insulator which protected the tab shaft from blow-by under the tab insertion. On three of the four tab assemblies, the insulator had eroded down to the tab shaft (Figure 5-23). On one part a small area of the steel shaft had been subjected to flame impingement and melting.

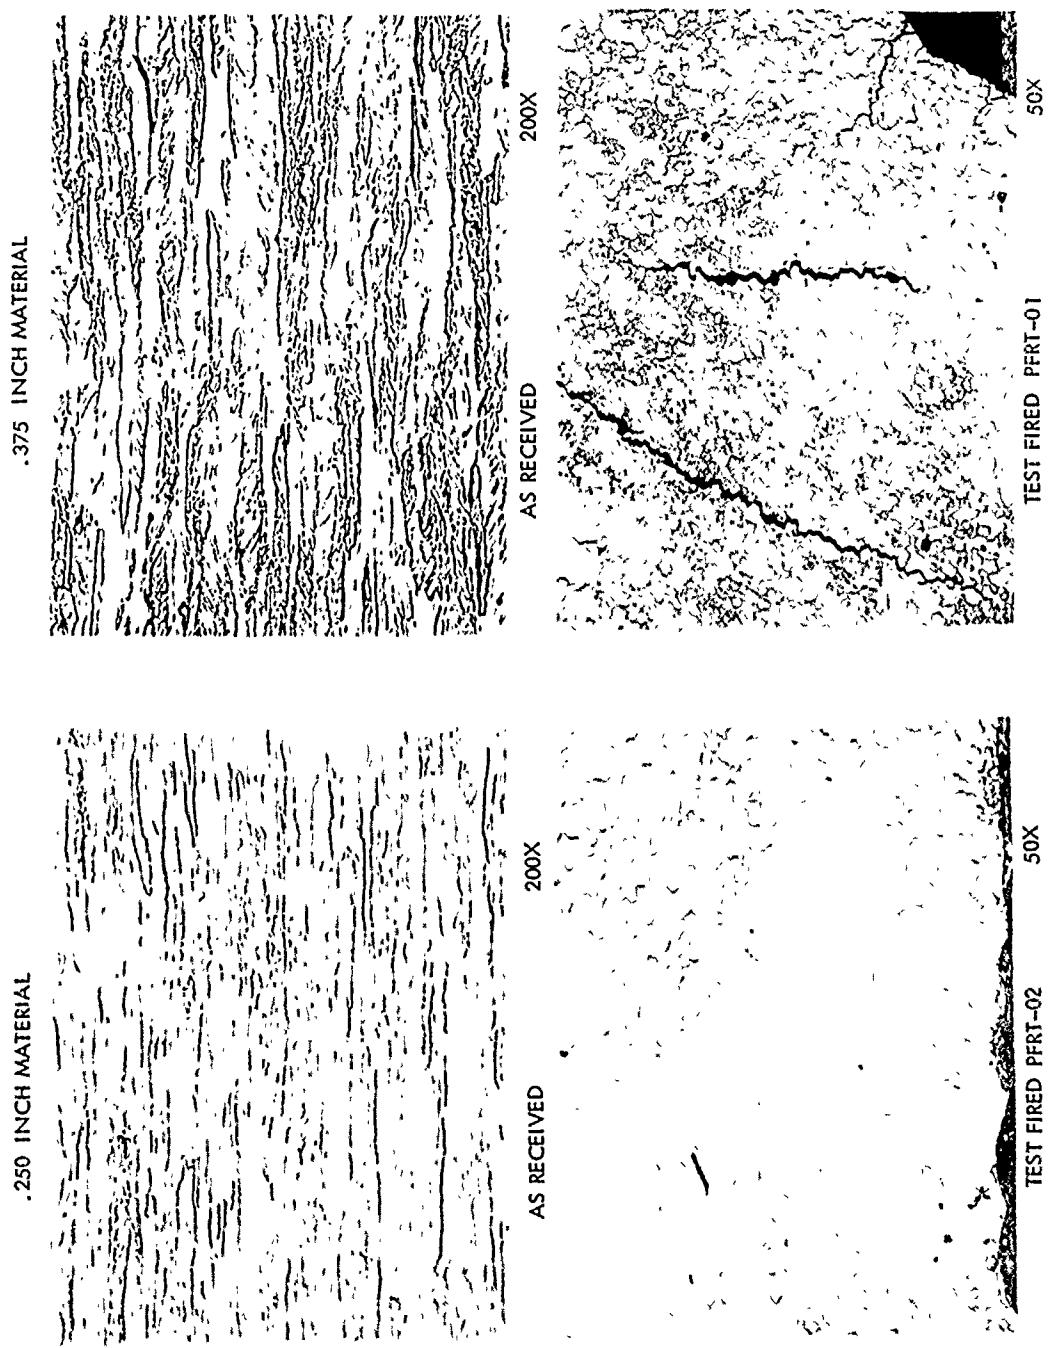
Figure 5-24. Tab Materials Grain Structure PFRT Test

As can be seen in Figure 5-24, differences were found in the post-test microstructure. The extremely large grain growth found in the thinner material is indicative of a much higher temperature, which would be expected to result in an increase in erosion rate. Thin material from product improvement test 2 was also sectioned. The large grain structure, Figure 5-25, was again evident. However, in the product improvement tests, the erosion of the .25 inch material, while not excessive, was greater than that experienced with the .375 inch part. This apparent inconsistent performance of the thin molybdenum material was evaluated further on the next PFRT test unit prior to final material selection.

Considerable subsurface cracking was noted in the .375 inch material. Cracks of this nature, occurring during the firing, could result in spallation, and explain the high erosion on the PFRT test.

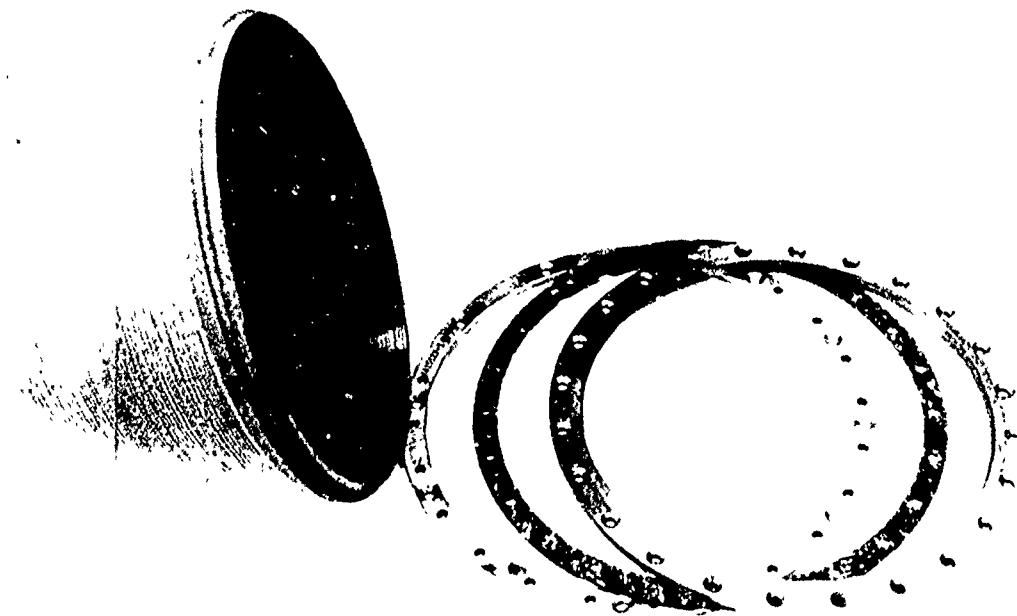
Figure 5-26. PFRT-3 Nozzle Liner

The last of the materials evaluation PFRT units was similar to the first two except that the exit area of the nozzle exit liner was modified to provide for a molybdenum scraper ring as shown in Figure 5-26. This approach was the back-up configuration in the event that the all ablative configurations had not been successful. To provide additional test data on the molybdenum tab face thickness, two tabs were provided with .25 inch material and two with .375.

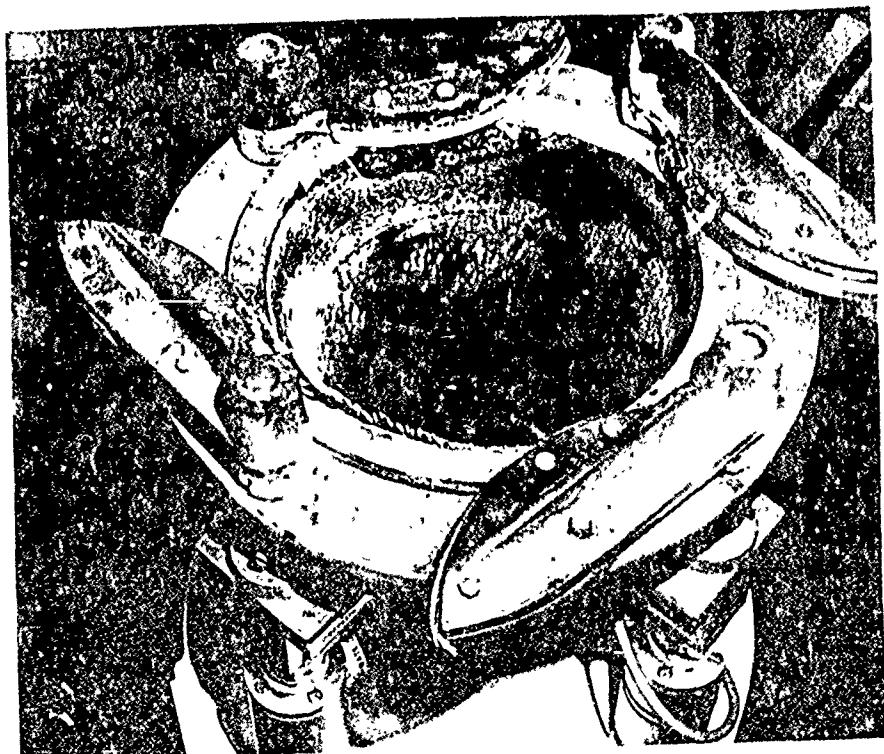
Figure 5-28. PFRT-3 Post Test

This test firing was the first to be made using the TRA GLICU. At the request of TRA, to allow the GLICU to be characterized, only the pitch tabs were actuated during the test. This, however, allowed data on only one tab of each material thickness. Two problems were encountered during pre-test check-out which could not be resolved prior to the test. The controller had been designed using the gain information from the potentiometers used on the JBQM-34H program. As that system had a higher voltage output per degree of rotation, the PFRT unit tabs would not drive in as far as desired on command. In addition, the controller had a built-in limitation for maximum command rotation angle of 33 degrees. As approximately 37 degrees of shaft rotation is required for six degrees of vector, the maximum thrust vector could not be demonstrated during this test. The test firing was conducted operating the pitch axis tabs to the duty cycle shown in Figure 5-27. Material performance throughout the tab system was excellent. The erosion of both tabs was minimal because of the low actuation angles achieved. The maximum rotation angle achieved was 28 degrees with a resulting 3.5 degrees of thrust vector. The post test appearance of the unit is shown in Figure 5-28.

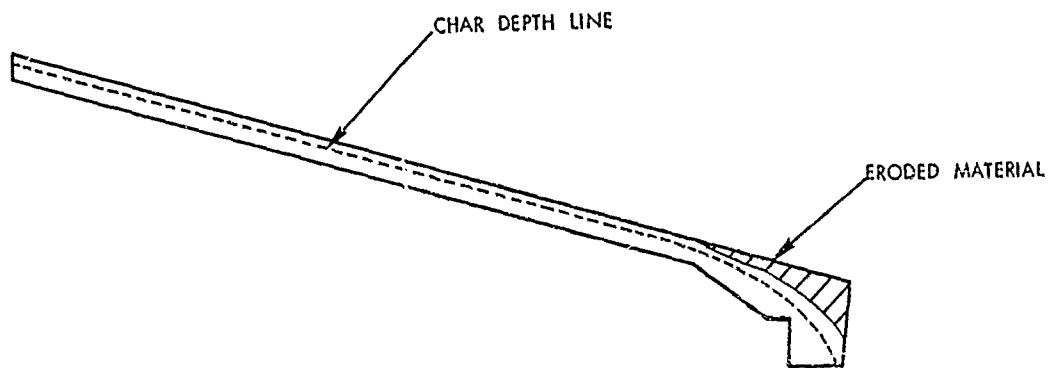
Figure 7-7. Nozzle Liner Char Depth

The predicted thermal margin of the liner is quite substantial as was discussed elsewhere in the report. A sectioned liner was examined to determine in-depth charring and surface ablation. Figure 7-7 illustrates the condition of the liner that was fired in unit PFRT-5. The section was taken at the location of maximum erosion underneath tab 1 (which had

the longest insertion time). Since the char and erosion depths were much less than the material thickness, it can be concluded that the existing design is extremely conservative. Char depth data was determined by visual observation as well as qualitative changes in material hardness that are indicative of the heat affected zone in the resin system. No corrections were made for char swell or post test heat soak.

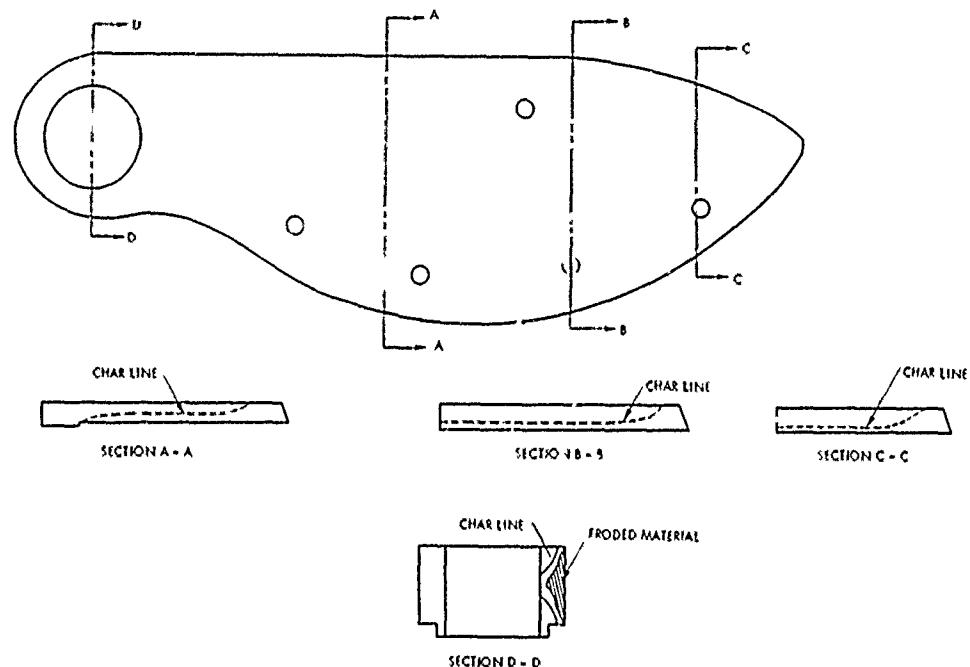
Figure 7-8. Tab Insulator Char Depth

The blade insulator thickness and material was selected on the basis of TRW experience and the results of the product improvement tests. Configurations similar to the tab unit cross section used have survived for over 20 seconds of tab insertion time. To confirm the thermal margin for the tab system, the insulator from tab 1 of unit PFRT-05 was sectioned in four locations to allow measurement of in-depth charring. The insulator survived with the major portions being unaffected by heating. Erosion was experienced around the shaft insulator due to impingement of alumina contained in the exhaust products. The char and erosion characteristics

are shown in Figure 7-8. The relatively deep char at the insulator leading edge is attributed to the constant exposure to the axial flow exhaust. The shallow char depth on the face of the insulator results from thermal conduction from the blade.

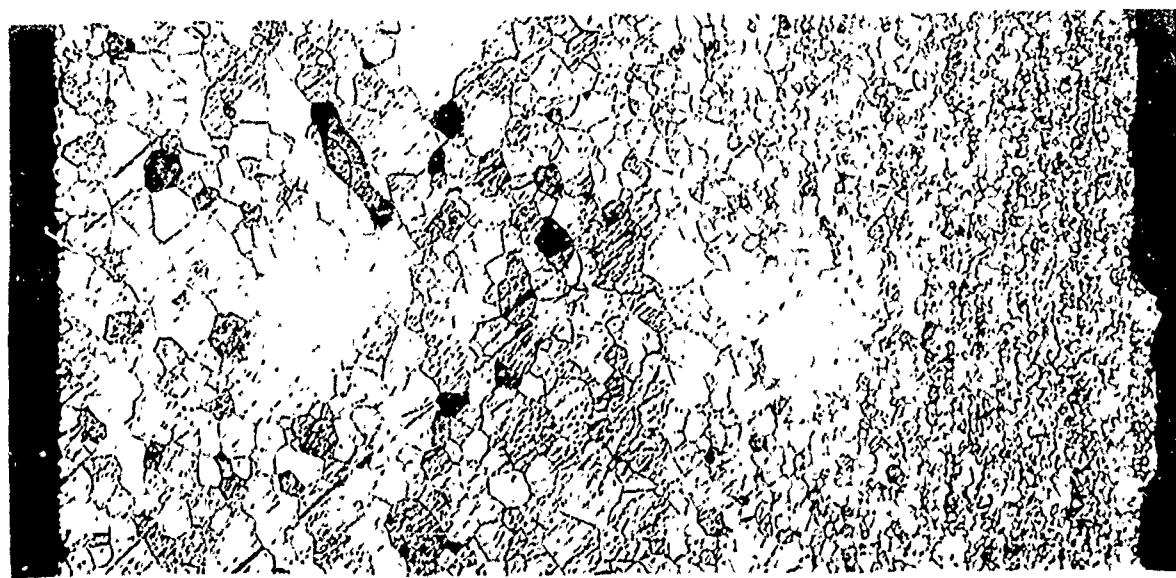
Figure 7-9. Tab Facing Microstructure - 27X - Tab 1 - Test PFRT-07

As can be seen from Figure 7-9, complete recrystallization of the structure had occurred. The larger grain sizes nearer to the flame surface are typical for extended exposure. The absence of subsurface cracks noted in the .25 inch material tested, is a typical condition found in the thinner grain oriented material. A small amount (0.03 inch) of surface regression experienced resulted from the loss of single large grain crystals (Figure 7-10) rather than subsurface cracking and spallation.
